EAST PALESTINE DERAILMENT – SOME INFORMATION & SOME QUESTIONS

Building Environment Council of Ohio 2023 BECO Annual Conference November 16, 2023

Stephen Petty, P.E., C.I.H., C.S.P President, EES Group, Inc. November 16, 2023

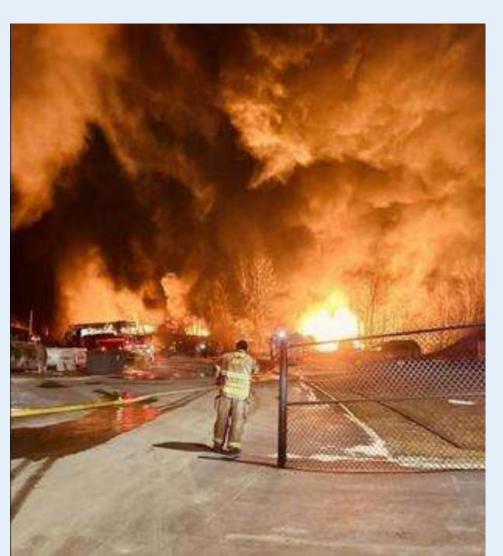
Feb. 3, 2023: Contents of Derailed Cars Burning

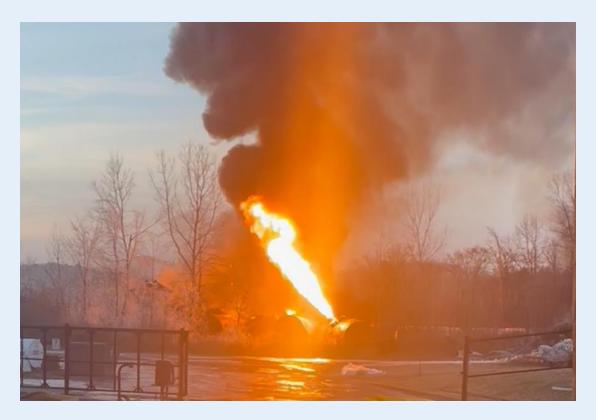
Feb. 4, 2023: Vinyl Chloride Car PRV Venting

After releasing material, the PRD Closed and Remained Closed (Source: NTSB)

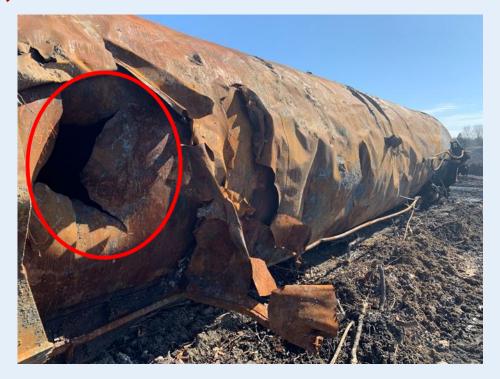
Feb. 6, 2023 (~4:30 PM): 5 Vinyl Chloride Cars blown up with shaped charges "Controlled Burn" releasing contents to soils, waters, and air.

- ➤ Why was the all clear given on Feb. 8th when contamination hadn't been determined drinking a glass of water a flawed basis.
- Why were almost all of the home air monitoring data based on a VOC PID? Did not measure individual contaminants and won't measure ppb.
- Why were the 5 VC cars blown up? Why not off-load contents?
- Who made the decision to blow them up?
- Why was the blow-up decision allowed to proceed with the declared evacuation zone when atmospheric conditions changed?
- What is the extent of contamination and what does it mean?

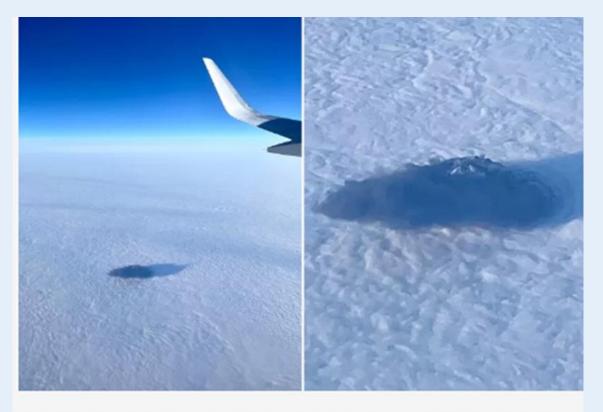
The picture taken from the sky by Jared McLuhan during flight AA1313 on February 6, 2023. McLuhan was on the passenger plane flying from Denver to Philadelphia when he captured the picture of the sky above East Palestine, Ohio just moments after a controlled explosion was ordered on the train that derailed there three days prior.

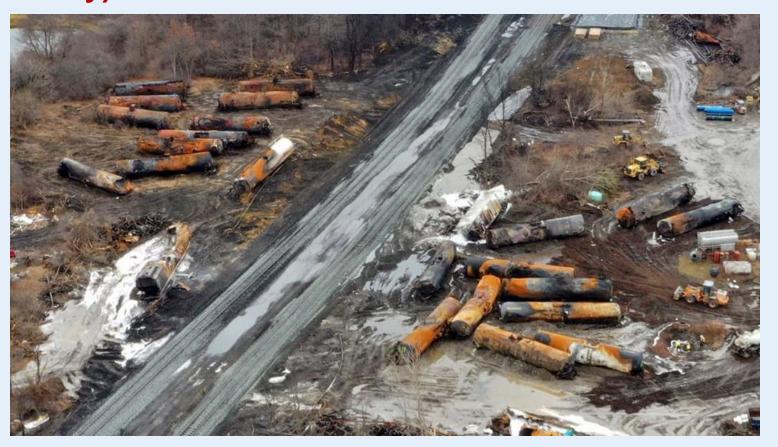
Feb. 8, 2023 (evening): Trains Running Again – Debris removed, rails, ties & ballast removed, ballast, ties, and rails replaced – contamination left behind under tracks (removed in April/May).
